## Arboricultural Impact Assessment Report

**Prepared for:** Ruden Homes Limited

**Proposed site:** Courtstown, Little Island, Co. Cork

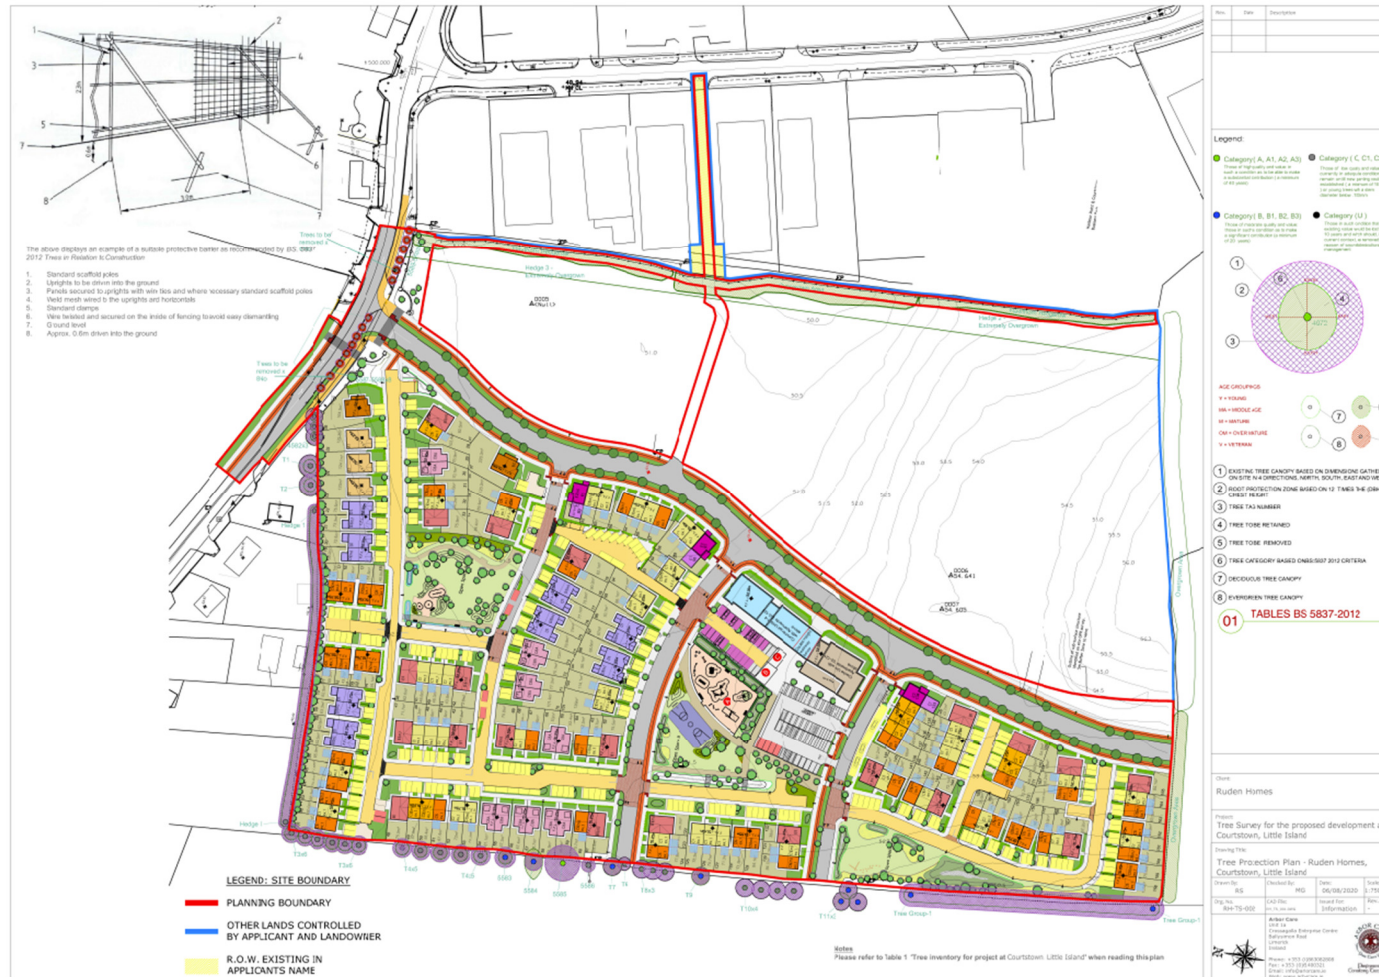
## Appendix 2. Tree Protection Plan

The arboricultural impact of the proposed development on the site will initially be low. It is proposed to remove 14No semi-mature Lime trees on the Ballytrasna road to facilitate the development. These trees are identified on drawing No RH-TS-001 and are noted for removal in Appendix 1 -Tree Inventory of this document. Some minor tree works that would involve the pruning of overhanging limbs from trees along the western boundary may have to be undertaken.

Overhanging limbs from the trees located within the golf course may have to be pruned back to allow for development works. All the above shall be carried out by qualified and insured tree surgeons and in accordance with *BS 3998: 2010 Tree Works. Recommendations*
