Courtstown Housing Development
Little Island, Co. Cork

Stage 1 Road Safety Audit

June 2024

Client	Ruden Homes Ltd.
Project Title	Courtstown Housing Development
Document Title	Report for Stage 1 – Road Safety Audit
Job No.	21008TT
Document No.	21008TT-Doc05

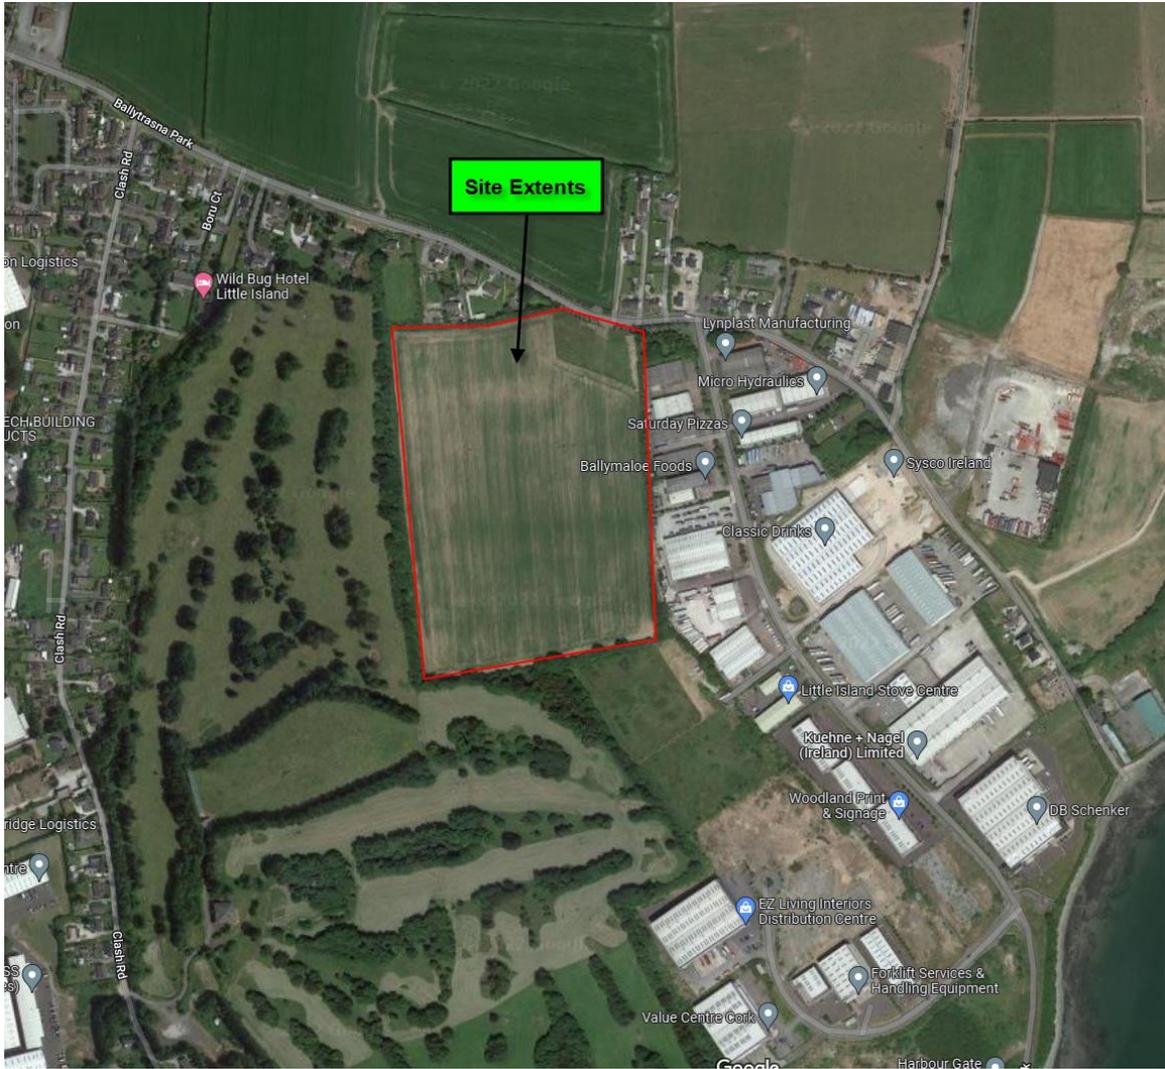
Figure 1.2 – Site Extents

See Figure 1.1 Site Location Map. Figure 1.2 shows the site extents on aerial photography, Figure 1.3 shows the proposed junction alterations and Figure 1.4 shows the proposed site layout.

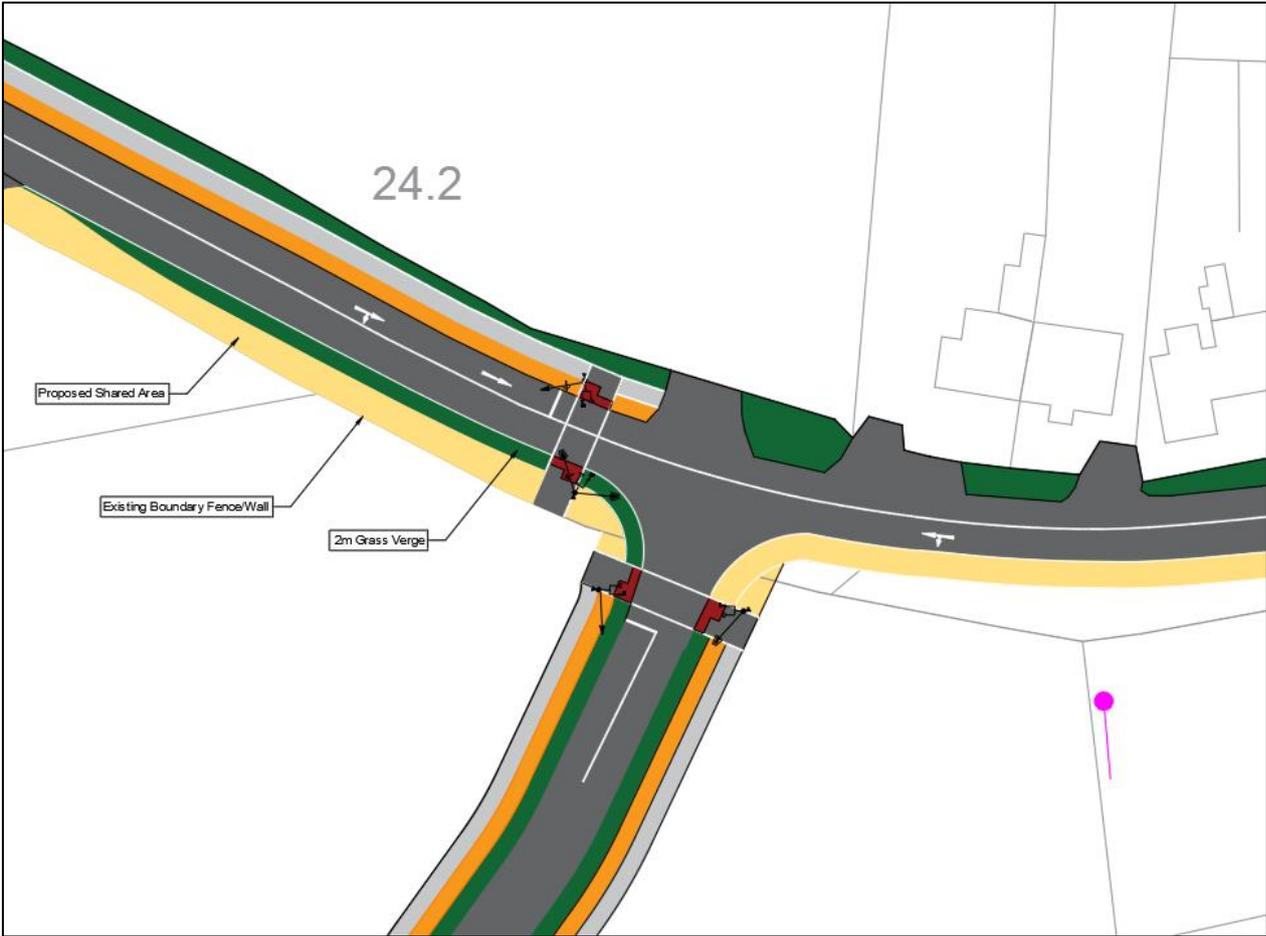
Figure 1.3 –Proposed Site Entrance

The site will be served by individual vehicular access junction onto Ballytrasna Park Road. Refer to Figure 1.3 below. This audit considers the development access points onto the public road and facilities on the access road and public road and footway.

The development is to be accessed via a new signalised junction located within the 50kph speed control.

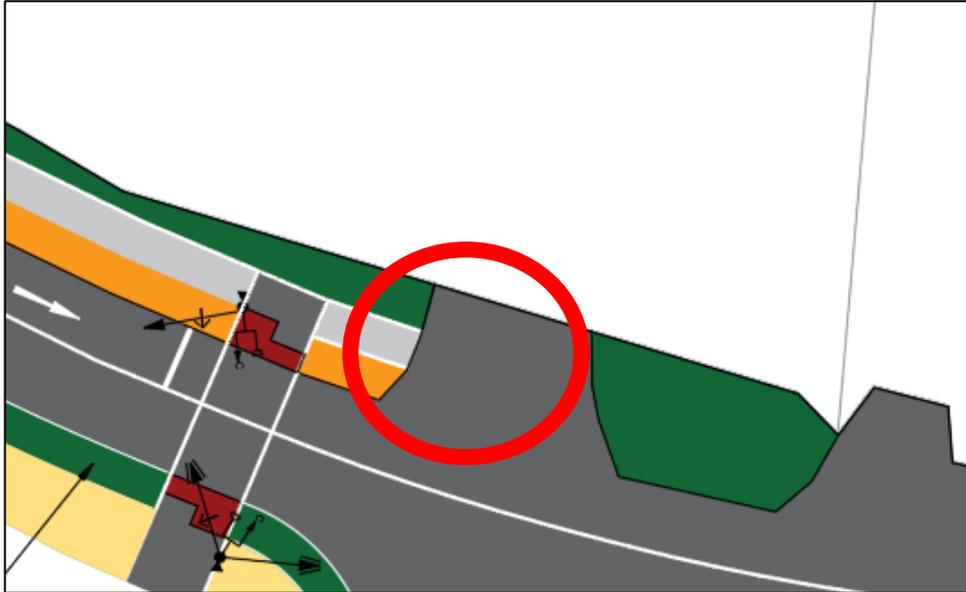
Figure 2.1, Discontinuity of Cycle Lane & Footpath

The cycle lane and footpath on the northern side of the western approach ceases following the pedestrian/cycle crossing. This could result in hazardous conditions for both pedestrians and cyclists merging with vehicular traffic. Refer to Figure 2.1.

At detailed design the proposed tie-in should be in line with the proposed council scheme for this area.

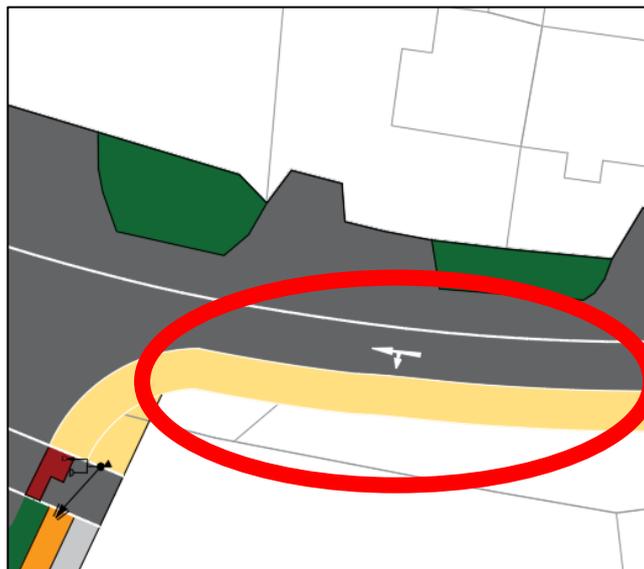
Figure 2.2, No Stopline or Traffic Signal

The eastern approach road has no traffic signals or stop line at the proposed signalised junction. This could result in traffic approaching from the east and not stopping at the junction putting other vehicles, pedestrians and cyclists at risk. Refer to Figure 2.2.

Ensure a stop line and traffic signal is included in all directions of the junction.

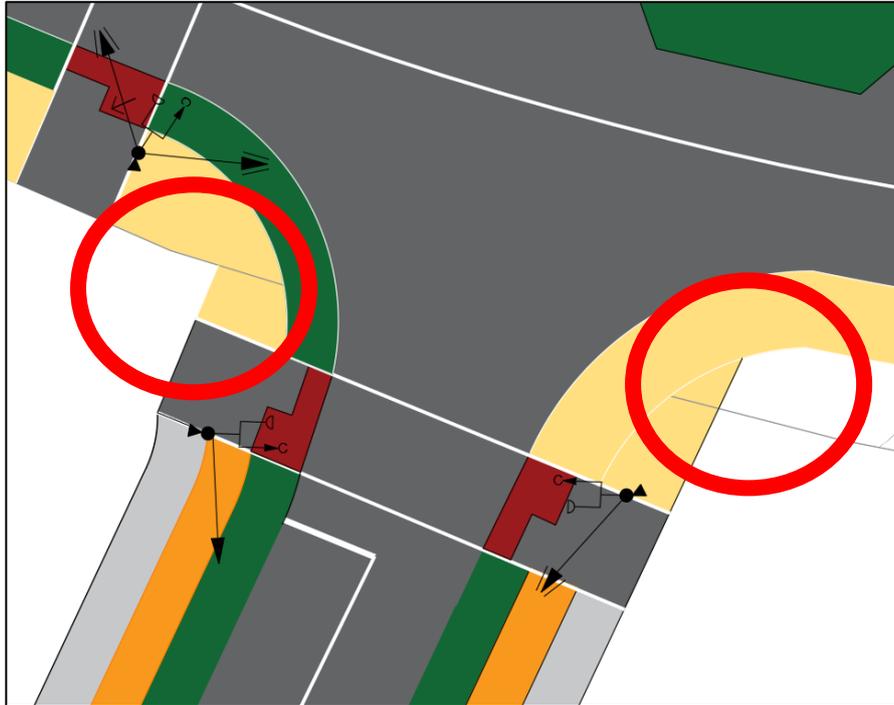
Figure 2.3, Radius of Shared Surface Acute

There is no radius on the shared surface on the exit from the proposed site. This acute angle could result in collisions between cyclists and pedestrians as they turn the corner.

At detailed design these corners should be designed with appropriate radii to ensure the safety of the users and to enable it to tie in with the proposed council scheme.

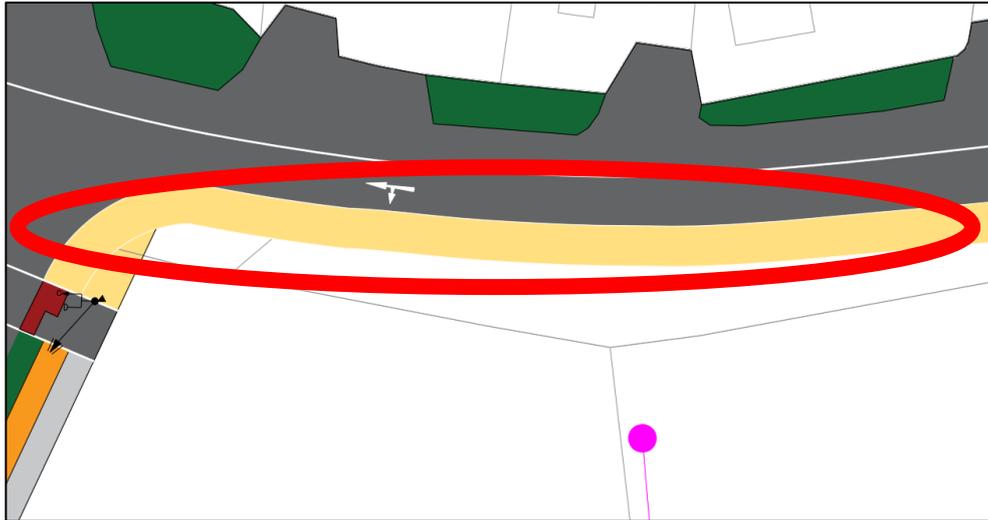
Figure 2.4 Eastern Approach shared surface width

The shared surface width along the eastern approach is not in line with the proposed council's scheme for the Courtstown area. This could result in collisions between cyclists and pedestrians travelling on this surface.

The shared surface width should be altered to reflect the proposed Council Scheme.

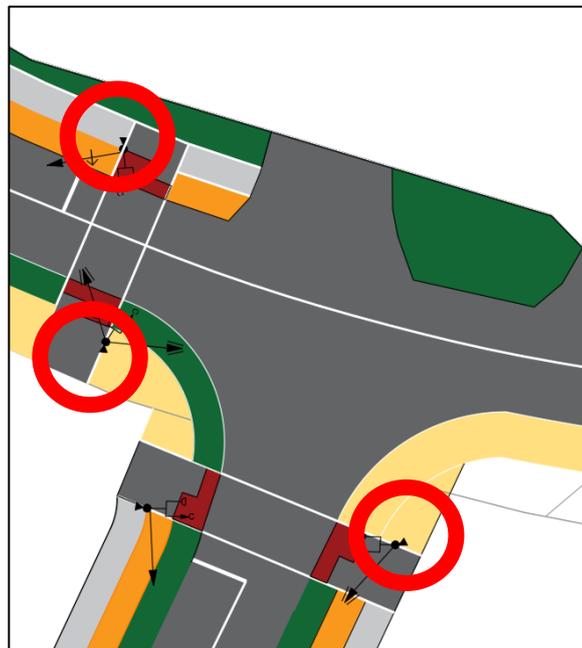
Figure 2.5 Traffic signals in the middle of the cycleway

Traffic signal poles are shown located between the footpath and the cycle lane within the travelled area. This could lead to incidents for the visually impaired and cyclists.

The designers should consider relocating the traffic signals to areas which do not obstruct any road users.

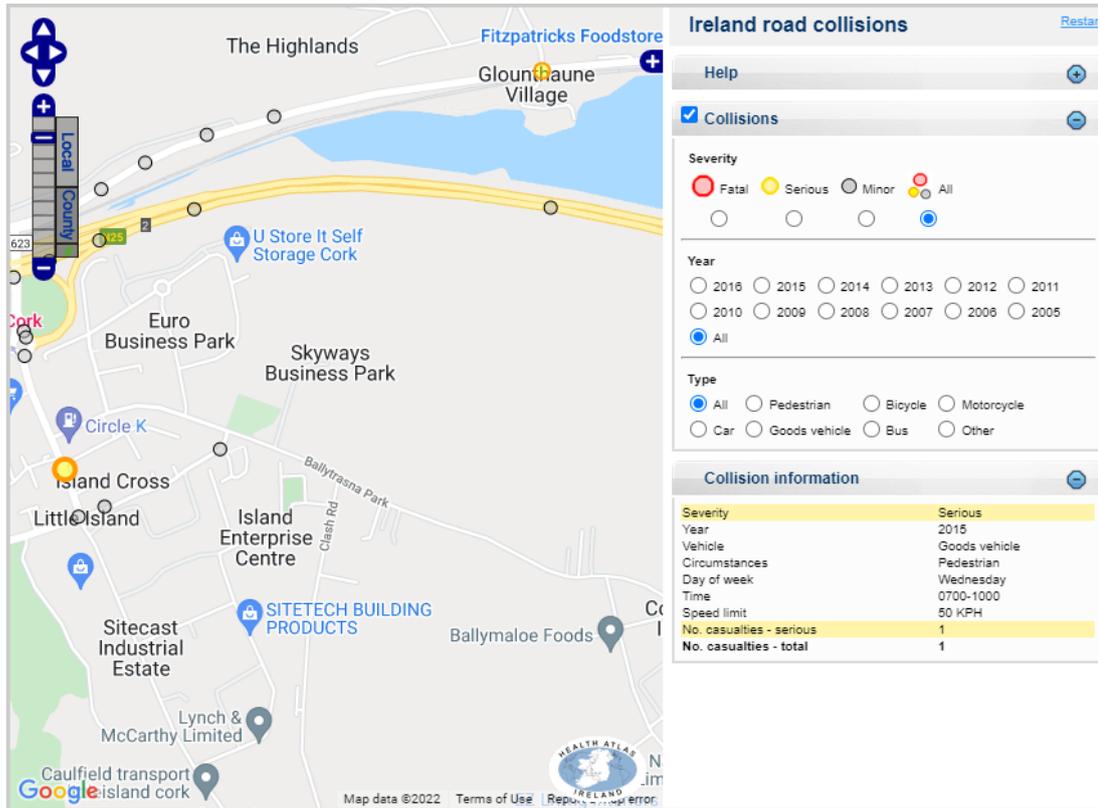
Fig 1 RSA Collision Statistics for Site Location

No specific Road Collision data was provided to the audit team. The auditors reviewed the RSA Road Collision Statistics, in the vicinity of the applicant site. No traffic collisions were reported in the period 2005 – 2016.
